Field Report for site visit 04.21.10
Chemetco Inc., Hartford, IL Superfund site
EPA ID: ILD048843809

Stormwater Construction Site Inspection Report

General Information			
Project Name	Estate of Chemetco, Inc.		
NPDES Tracking No.	IL0025747	Location	Hartford, IL
Date of Inspection	04.21.10	Start/End Time	1pm
Inspector's Name(s)	Michelle Kerr		
Inspector's Title(s)	Remedial Project Manager		
Inspector's Contact Information	312.886.8961, kerr.michelle@epa.gov, 77 W. Jackson Blvd. (SRF-6J), Chicago, IL 60604		
Inspector's Qualifications	U.S. EPA Remedial Project Manager delegated authority from CERCLA Section 115 via National Contingency Plan Subpart E		
Describe present phase of construction	Proposed demolition plan for Foundry Building and interior of Tank House under review by ILEPA, US EPA		
Type of Inspection: <input checked="" type="checkbox"/> Regular <input type="checkbox"/> Pre-storm event <input type="checkbox"/> During storm event <input type="checkbox"/> Post-storm event			
Weather Information			
Has there been a storm event since the last inspection? <input type="checkbox"/> Yes <input checked="" type="checkbox"/> No N/A If yes, provide: Storm Start Date & Time: Storm Du

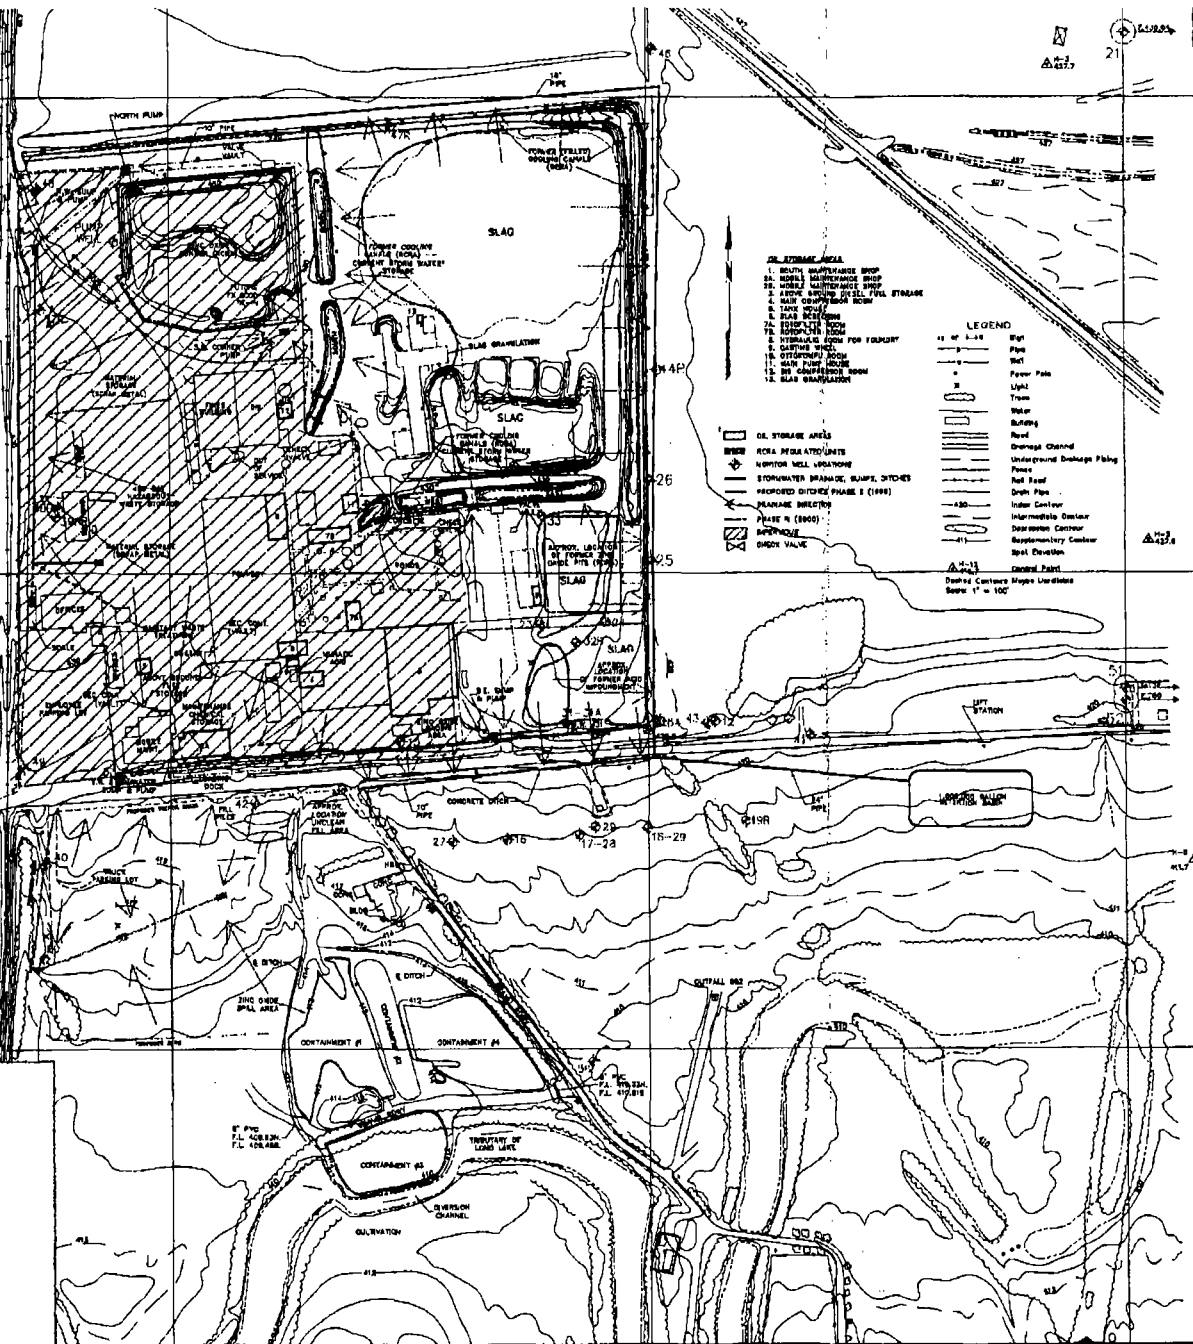
OIL STORAGE AREAS
IN SECTION 15 AND 16, T.4N., R.9W., 3RD P.M.
CHOUTEAU TOWNSHIP, MADISON COUNTY, ILLINOIS

Fuel is stored primarily in the above ground containment area between the Maintenance Shop and the Admin Bldg. 2nd containment intact, no leaks observed. Empty tank 2500 gal. gas located at former ZnO pits. Closed, removed c. 1989 UST 2000 gal. located between fuel

storage area and maintenance shop. Six 33 lb. cylinders of propane are stored at the NE corner of the Maintenance Shop. Other storage includes 250 gal. tank of kerosene, one-1000 gal. tank of used oil, and 2-2500 gal. diesel tanks of which there is ~500 gal. of actual fuel, and <10 hydraulic systems onsite generally inside bldgs. One palette of 55-gal. drums of sulfuric acid is stored in the Maintenance Shop, 4-55 gal. drums of solvents in the baghouse control room, 1-55 gal. drum caustic in MS, 2-200 gal. caustic tanks in AAF area. One is empty steel, other ~200-500 gal. dilute in plastic. Also 2-3 gal. sulfuric in Estate lab, couple L caustic, ~4 gal. hydrochloric acid. There is also a bench scale lab in the Admin Bldg. that Paradigm Minerals & Environmental Services is operating that to date hasn't been inspected & inventoried. Additionally in the NW corner of the site is an oxygen line no longer in use that may present a pressure hazard. Fuel storage capacity ~8750 gal onsite, ~1750 gal in use plus propane. A map was made of hw/fuel storage locations.
